# Manhole Inspection Summary

Manhole # S45G\_\_021MH

**Location** Address: **Pratt**

Cross Street: **Castle**

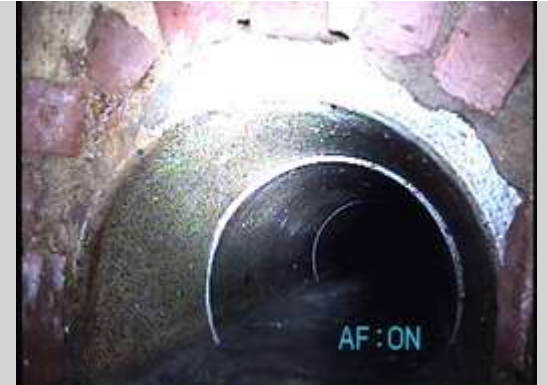
12 O'Clock Outflow

12 in. Circular Gravity Sewer  
Pipe Out @ 12 O'Clock

Pipe Height: **12** (in.) Rod and Bar (Angled)  
Pipe Material: **Clay** ☐ Pipe Lined  
Invert Depth: **12.35** (ft.) Flow Characteristics: **Fast**  
Deposits: ☒ None ☐ Mud ☐ Sludge ☐ Debris ☐ Grease  
Silt Depth: (in.) Deposits Extent:  
Infiltration: **None** Pipe Seal Cond: **Sound**

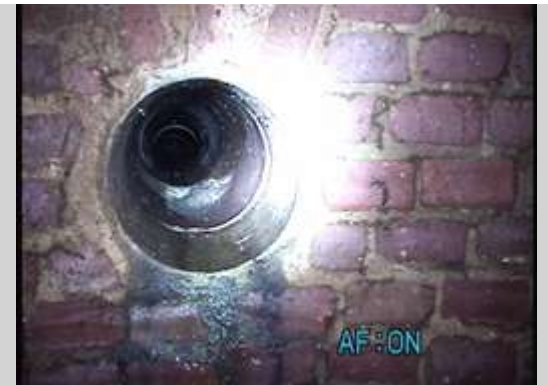
3 O'Clock Inflow

8 in. Circular Gravity Sewer  
Pipe In @ 3 O'Clock

Drop In @ 3 O'Clock

Pipe Height: **8.4** (in.) Rod and Bar (Angled)  
Pipe Material: **Clay** ☐ Pipe Lined  
Invert Depth: **10.65** (ft.) Flow Characteristics: **Slow**  
Deposits: ☒ None ☐ Mud ☐ Sludge ☐ Debris ☐ Grease  
Silt Depth: (in.) Deposits Extent:  
Infiltration: **None** Pipe Seal Cond: **Sound**

Drop: **Inside** Rod and Bar  
Angled: **Yes** Reading: **11.40** (ft.)  
Inv Depth: **12.40** (ft.)  
Drop Condition: **Clogged**

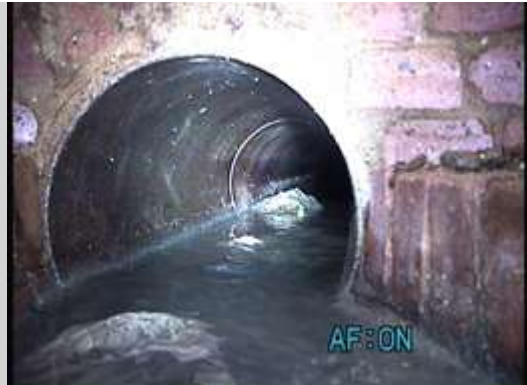
6 O'Clock Inflow

12 in. Circular Gravity Sewer  
Pipe In @ 6 O'Clock

Pipe Height: 12 (in.) Rod and Bar (Angled)

Infiltration: **None** Pipe Seal Cond: **Sound**
